Sumter County, Florida

A.D.A. Compliance Assessment Survey Report

100% Final
March 5, 2012

ADA Compliance Assessment Survey Report

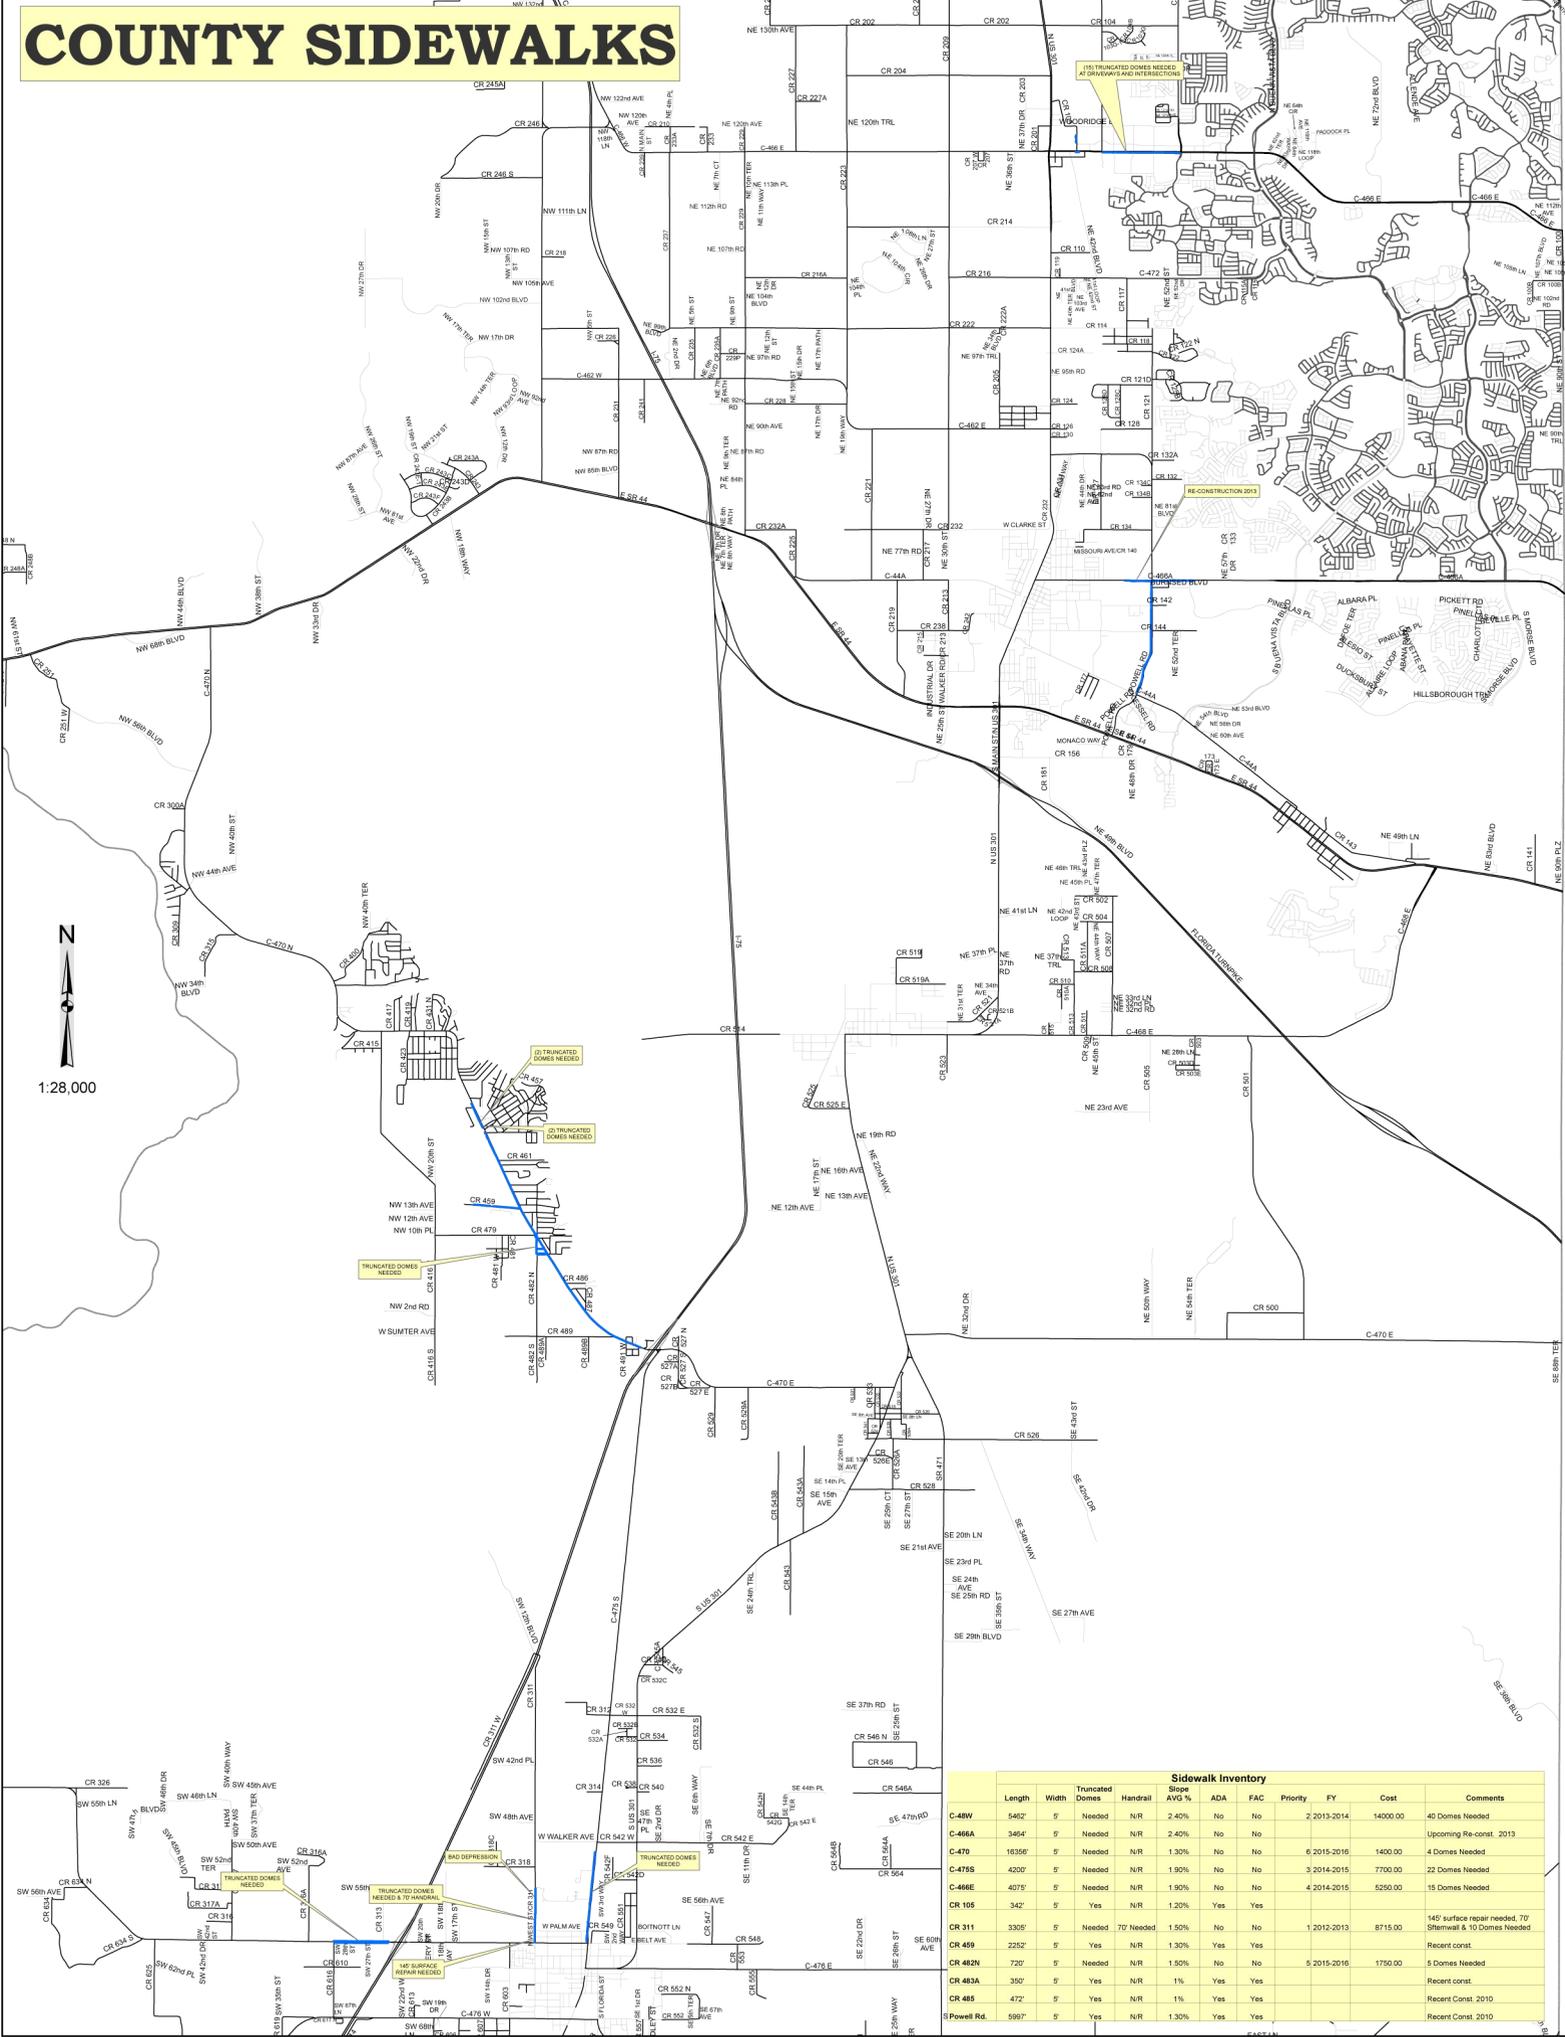
COUNTY SIDEWALKS

Sidewalk Inventory	Length	Width	Truncated Domes	Handrail	Slope			Priority	FY	Cost	Comments
					AVG %	ADA	FAC				
CR-48W	545'	5'	Needed	N/R	2.40%	No	No	2	2013-2014	14000.00	40 Domes Needed
CR-46A	3454'	5'	Needed	N/R	2.40%	No	No				Upcoming Re-const. 2013
CR-470	16356'	5'	Needed	N/R	1.30%	No	No	6	2015-2016	14000.00	4 Domes Needed
CR-475S	4200'	5'	Needed	N/R	1.90%	No	No	3	2014-2015	7700.00	22 Domes Needed
CR-466E	4075'	5'	Needed	N/R	1.90%	No	No	4	2014-2015	5200.00	15 Domes Needed
CR 105	342'	5'	Needed	N/R	1.20%	Yes	Yes				
CR 311	3305'	5'	Needed	70' Needed	1.50%	No	No	1	2012-2013	8715.00	140' surface repair needed, 70' Stenwell & 10 Domes Needed
CR 459	2252'	5'	Yes	N/R	1.30%	Yes	Yes				Recent const.
CR 482N	720'	5'	Needed	N/R	1.50%	No	No	5	2015-2016	1750.00	5 Domes Needed
CR 483A	350'	5'	Yes	N/R	1%	Yes	Yes				Recent const.
CR 485	472'	5'	Yes	N/R	1%	Yes	Yes				Recent Const. 2010
Power Rd.	5997'	5'	Yes	N/R	1.30%	Yes	Yes				Recent Const. 2010
